TEST REPORT

NO.: A001E131206011K

Sample name: Led Floodlight

As specified by client, to determine Degrees of protection provided by enclosure IPX6on the submitted sample(s).

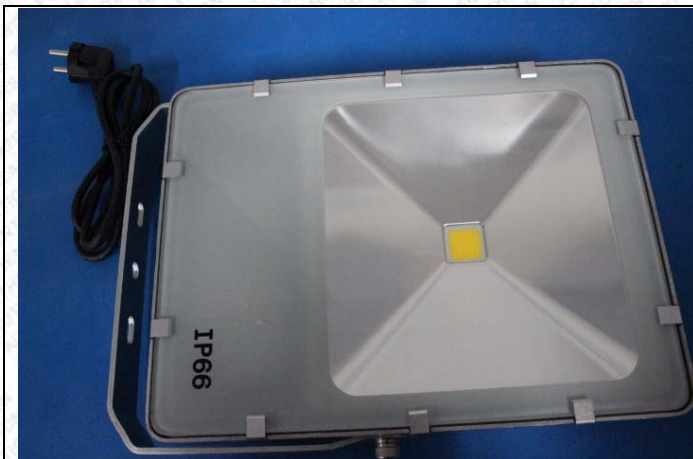
Photo 1 Before test sample view

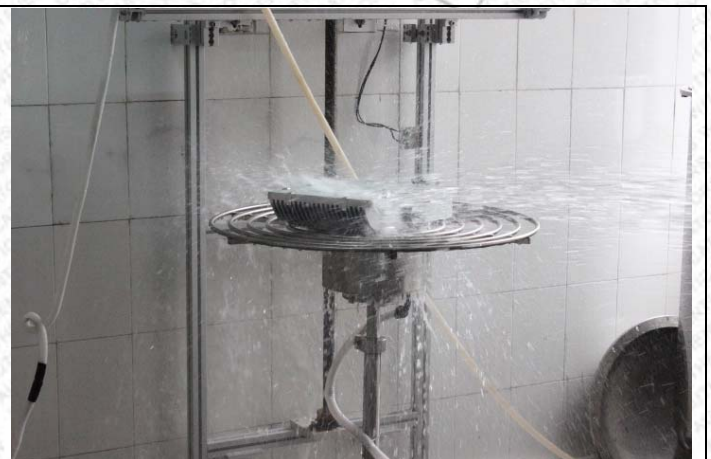
Photo 2 During test sample view

Testing Item(s)	IP X6 test
Testing Instrument	Water-proof test system
Testing Condition	Use diameter is 12.5 mm, distance 2.5 ~ 3 m, 100L/min Test time: 3min
Requirements of IPX6	No water or from the shell into the water will not affect the normal operation or destroy safety
Testing Result(s)	No ingress of water.
Conclusion	Pass

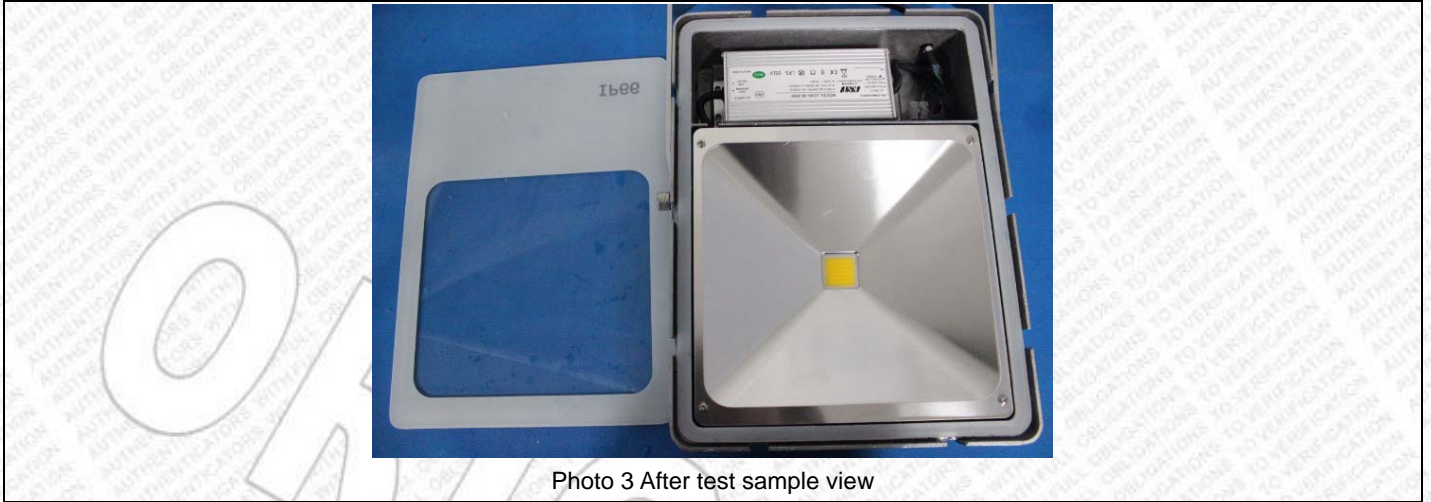
Photo 3 After test sample view
